CASQA 2015  
Awards Program

Nomination for  
Outstanding  
Sustainable  
Stormwater Project  
June 5, 2015

## Stevens Creek Corridor Park & Restoration, Phase 2

# STEVENS CREEK CORRIDOR PHOTOS

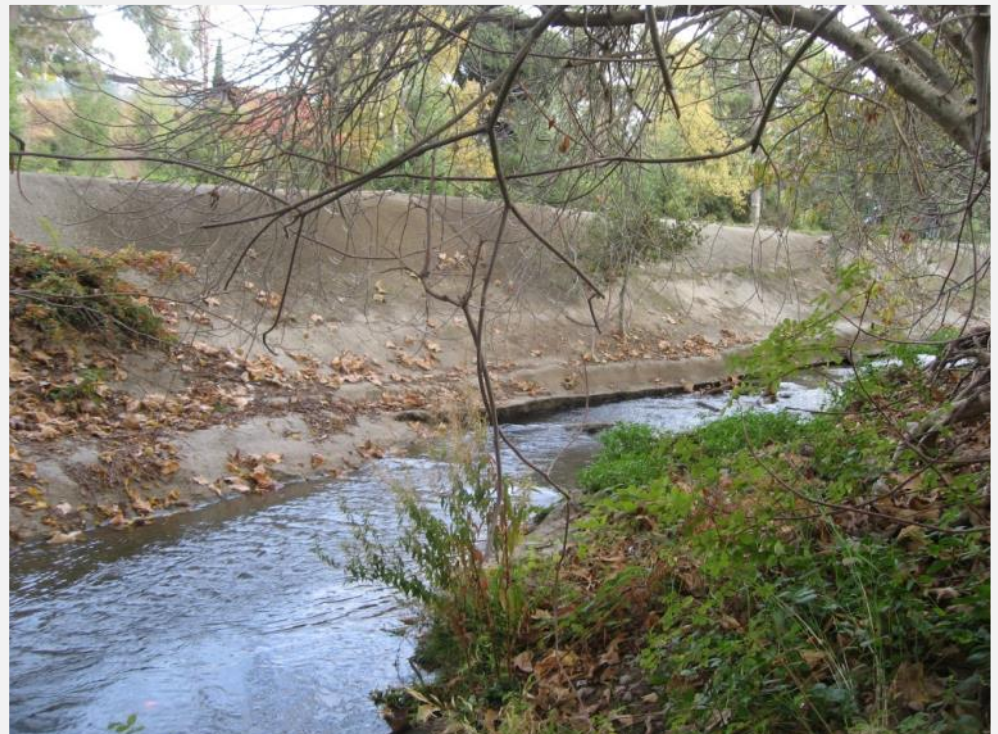
*Stevens Creek was in degraded condition. The creek was too narrow, it suffered from scour and incision, and lacked understory vegetation.*

*It was unable to maintain stable banks except through ongoing additions of bank armoring.*

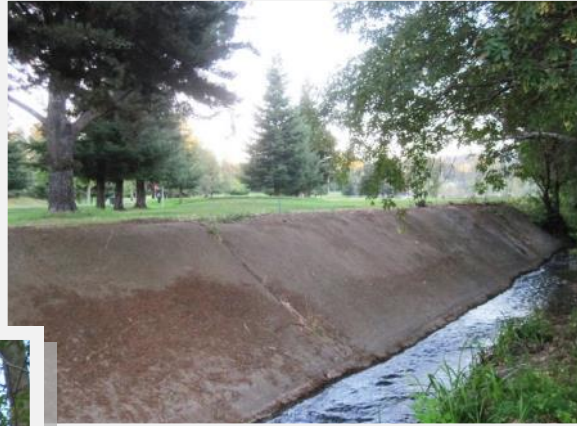
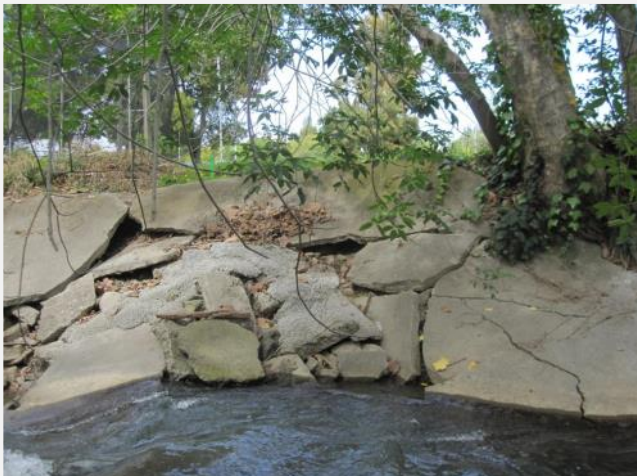
*Much of the east creek bank was lined with riprap or smooth concrete. This armoring forced the creek into a narrow, semi-trapezoidal channel.*

*Concrete lining was failing and falling into the creek.*

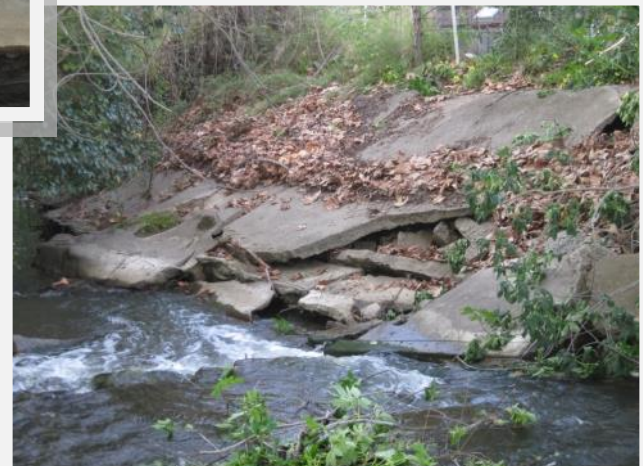
*Fallen concrete slabs were creating waterfalls and impediments to fish passage at low flows, left.*

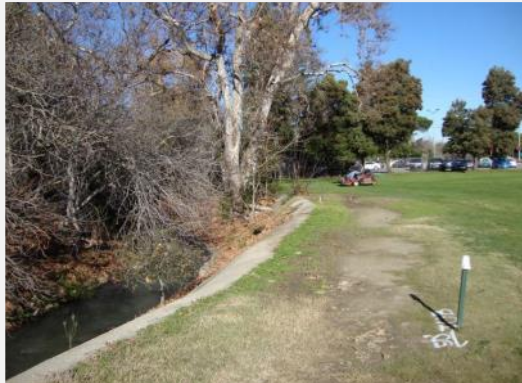
*The east side of the creek was compacted and had almost no vegetation.*

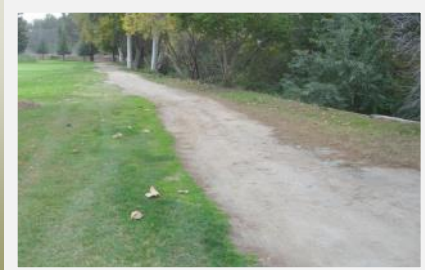
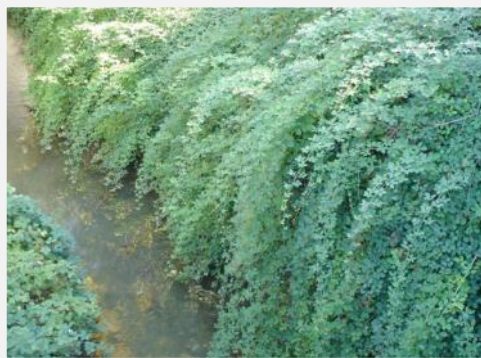
*Dense, nonnative Himalayan blackberry outcompeted the native understory.*

*Invasive vinca and ivy infested much of the creek corridor on both banks. Ivy climbed many of the trees.*

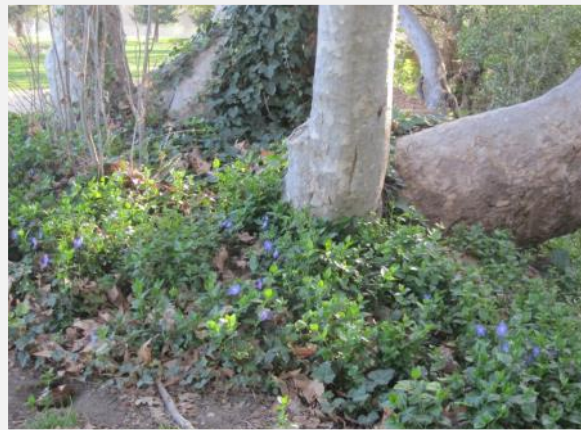
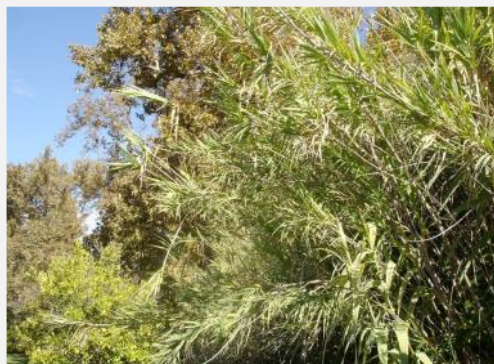
*Arundo, an invasive giant reed, had invaded this reach of the creek, photo left. A large stand was removed and excavated to create a new backwater feature.*

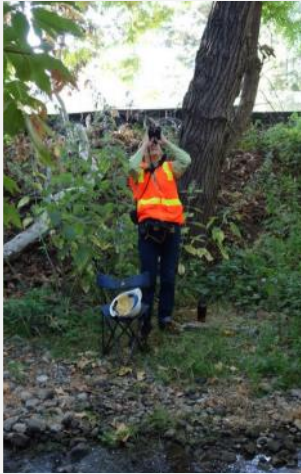
*P*rior to bird breeding season, nesting boxes were installed outside the work zone to encourage nesting in safe areas beyond the construction. City staff and Audubon Society collaborated on this action.

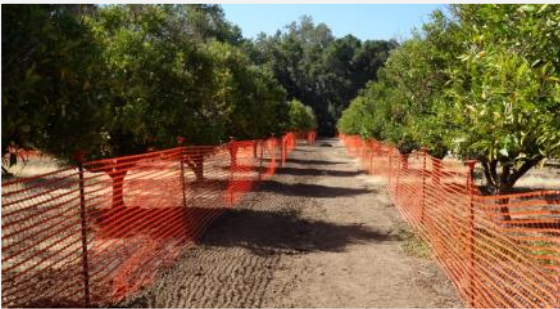
*T*rees in the heritage orchard and throughout the site were protected during construction as well.

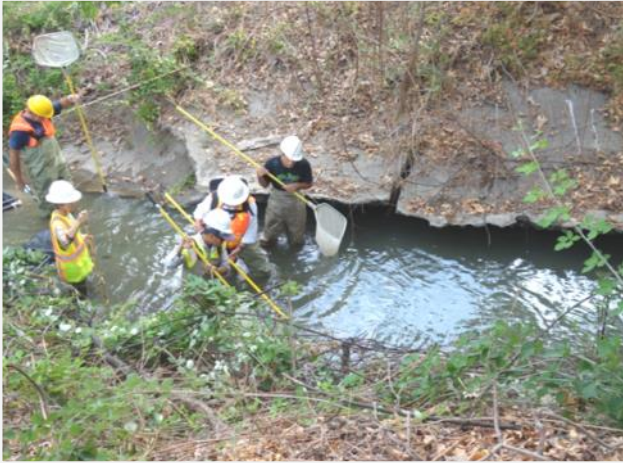
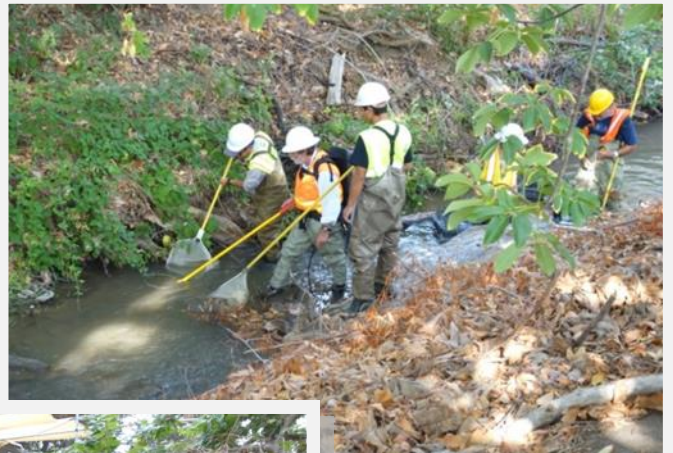
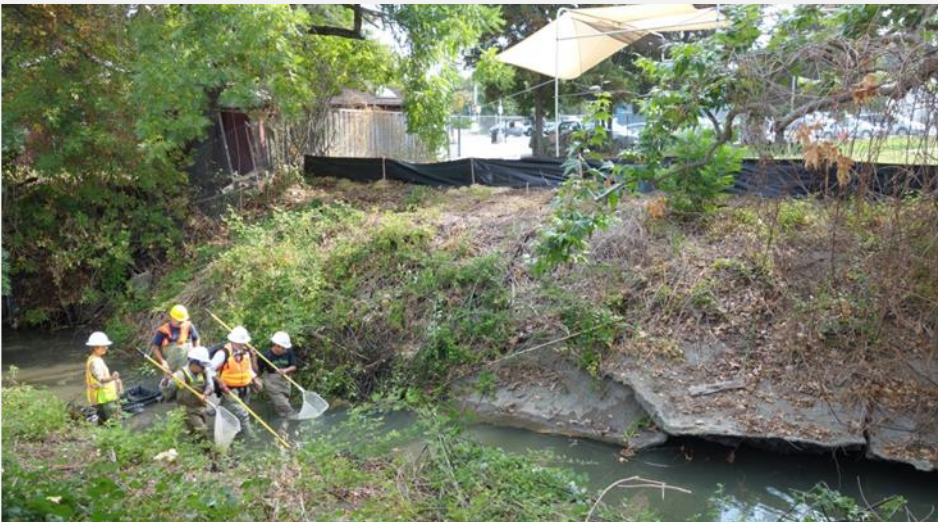
*Note that concrete channel lining was deeply undercut by scour forces from creek flows. Further failures of the lining may have been likely.*

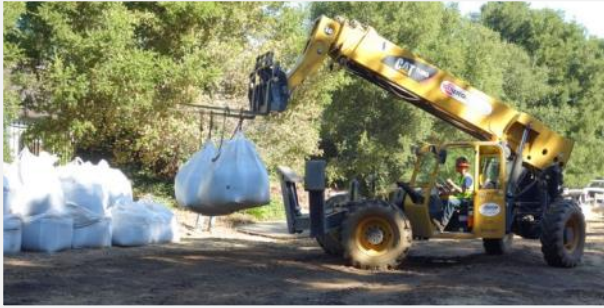
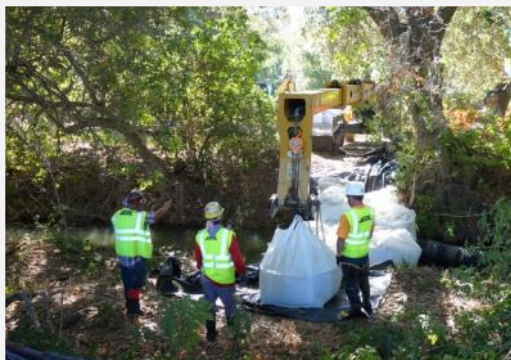
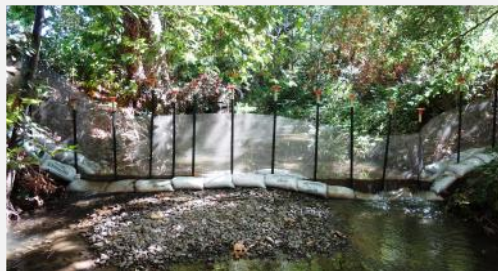
*Large bags filled with gravel were used to build coffer dams needed to dewater the creek in the work area. This design for the dams met permit conditions & allowed efficiency.*

*The heavy duty bags & gravel can all be re-used.*

*Fish screens prevented fish from entering the work zone & ensured permit compliance.*

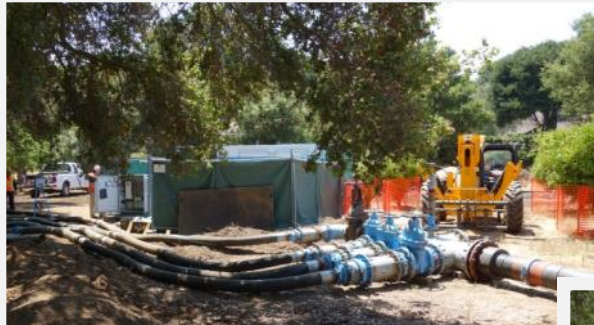
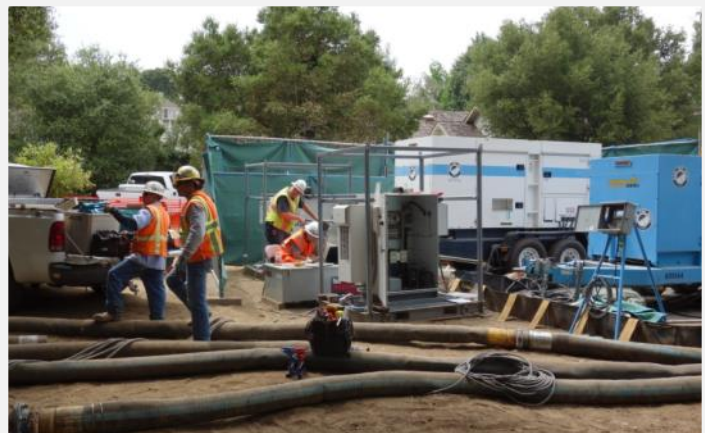
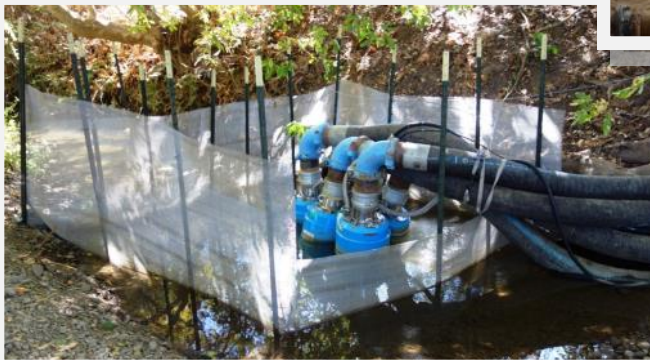
*The creek flows were routed around the work site during construction, with a flow diversion system subject to extensive regulatory requirements.*

*The flow diversion system involved 4 pumps and a control system to divert variable creek flows & maintain downstream conditions.*

*The flow diversion system had to keep the water cool. Allowable temperature rise was capped at 1.5 degrees Centigrade per permits. Most of piping was buried to help achieve this.*

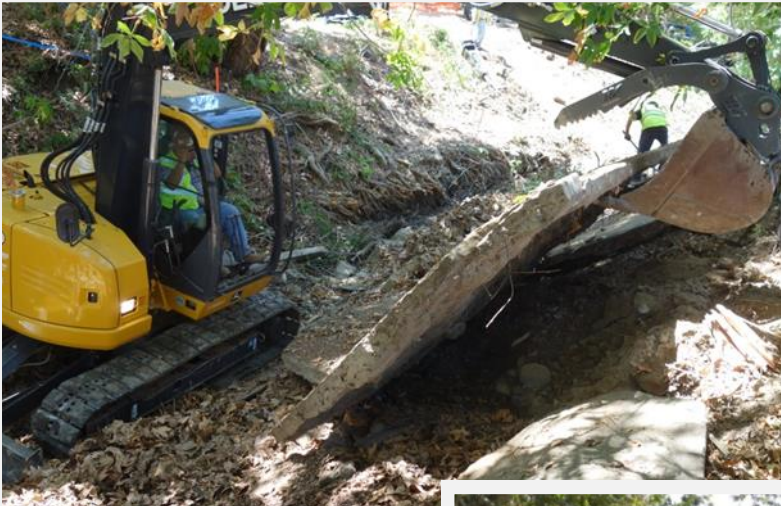
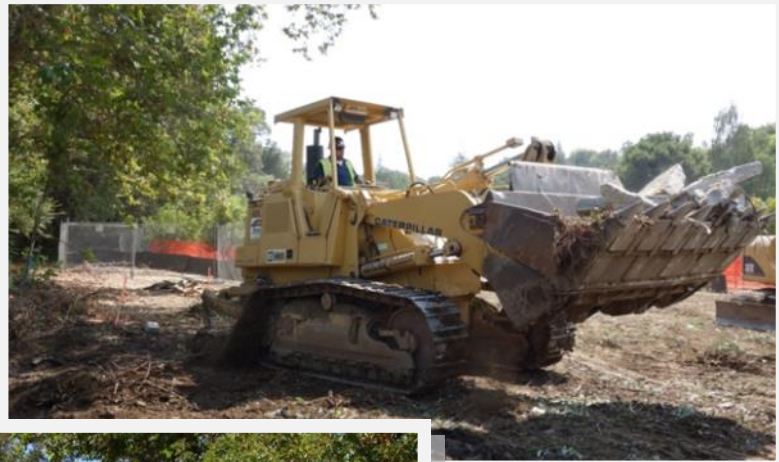
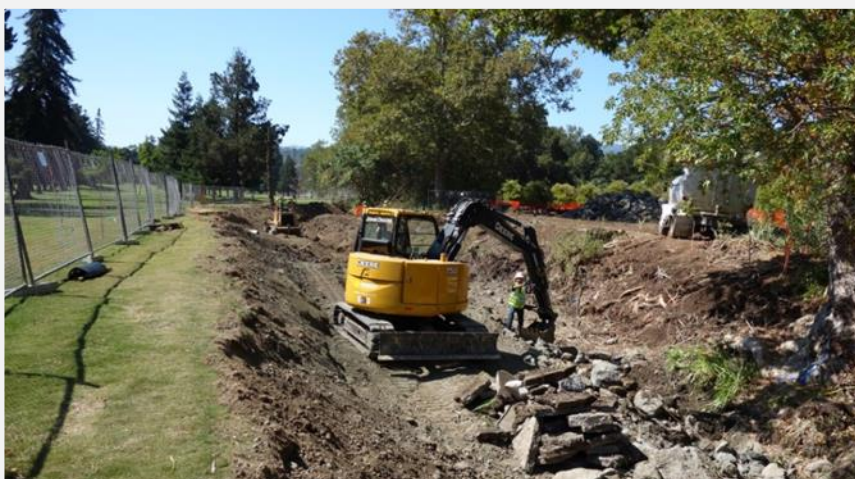
*Concrete bank lining was removed from the creek channel to allow widening and restoration.*

*All of the removed concrete was recycled.*

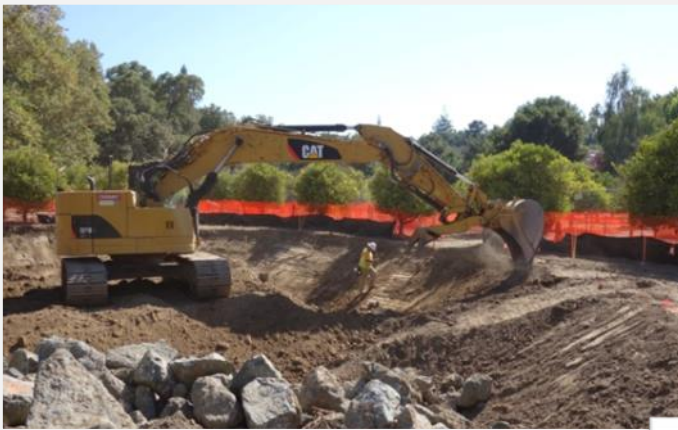
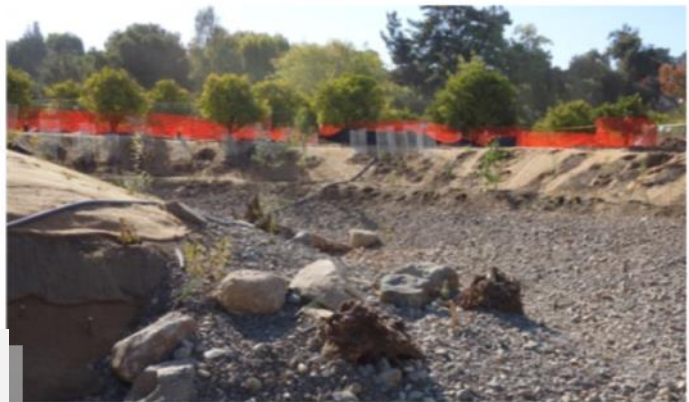
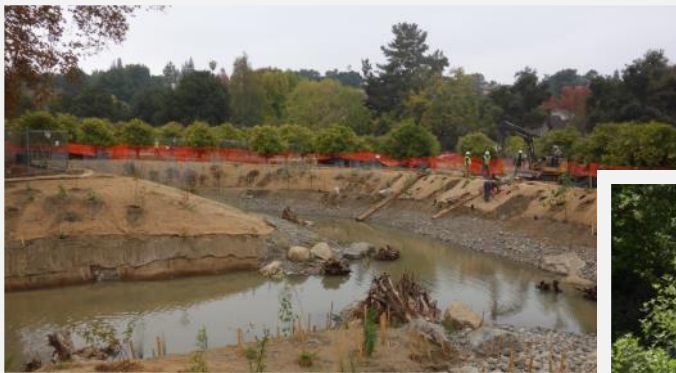
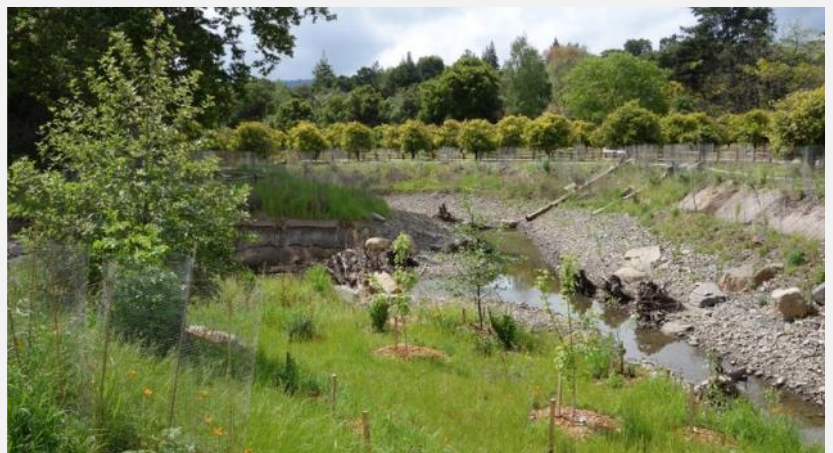
*Two new backwater areas were created. They provide habitat complexity & important wildlife refuge during high flows. Excavation of a new backwater, photo left.*

*New backwater, photo right, prior to channel rewatering, & photos below, after rewatering.*

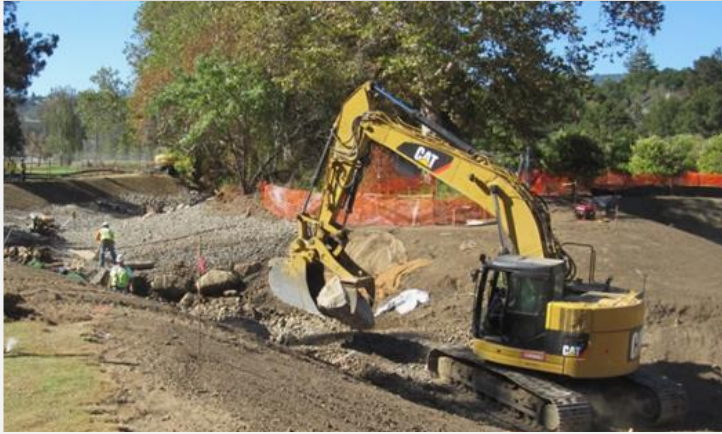
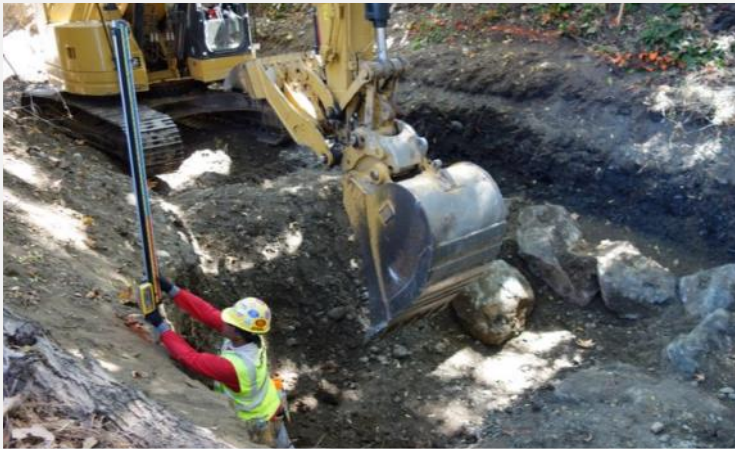
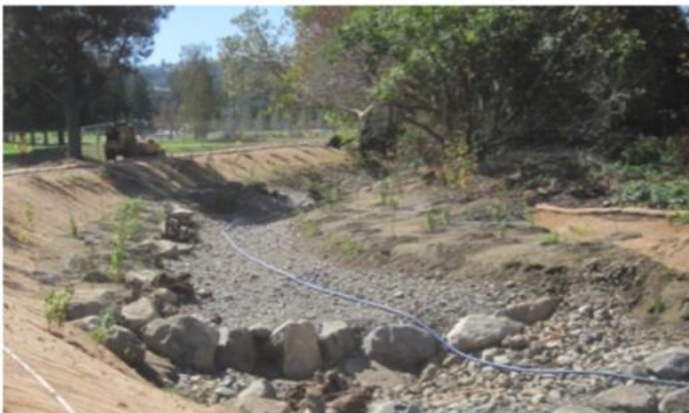
*Six boulder "steps" are a feature of the channel restoration. They are built using very large boulders; no concrete is used.*

*Boulder steps stabilize the elevations of the channel and maintain gentle slopes for riffle sections. They are designed to facilitate fish passage for steelhead.*

*Boulder step, photo left, prior to creek rewatering.*

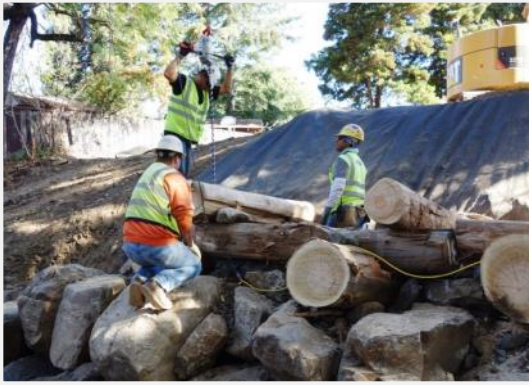
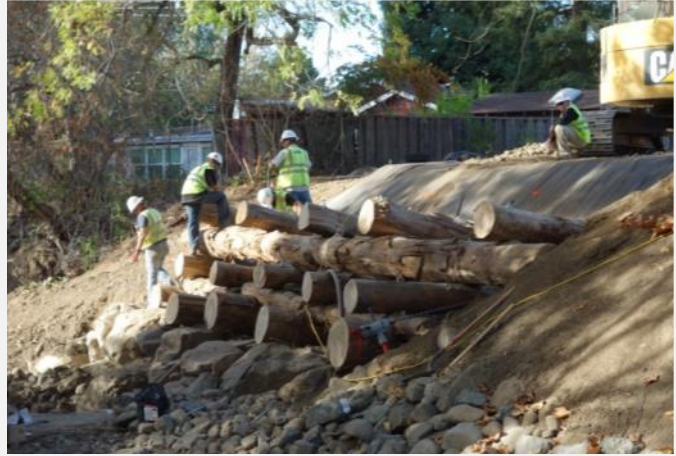
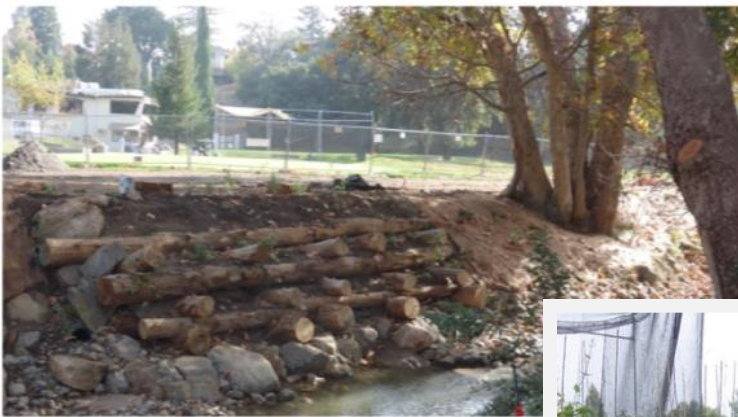
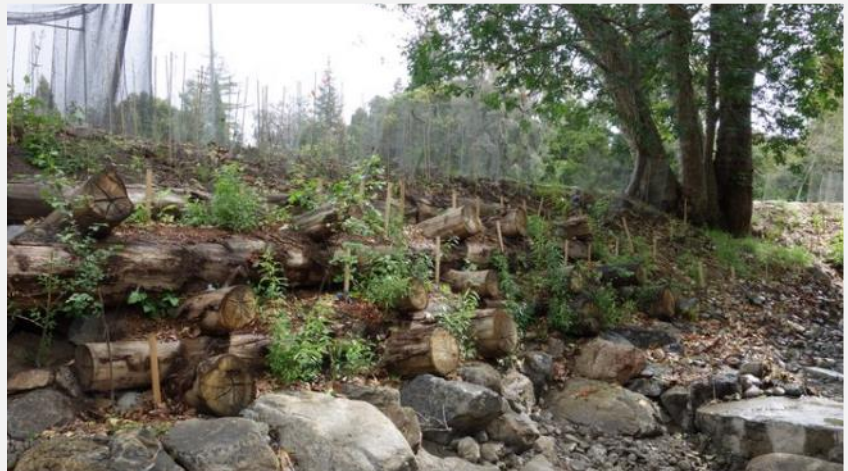
*A log crib wall replaces a concrete bank and stabilizes this area using natural methods.*

*The crib wall is planted with willows & other riparian plantings to further enhance long-term stability and to improve habitat. P*

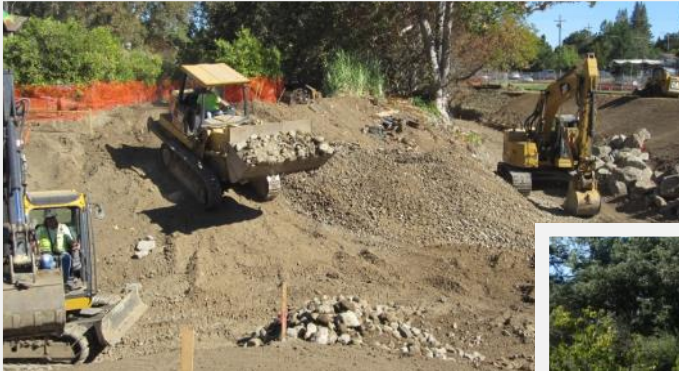
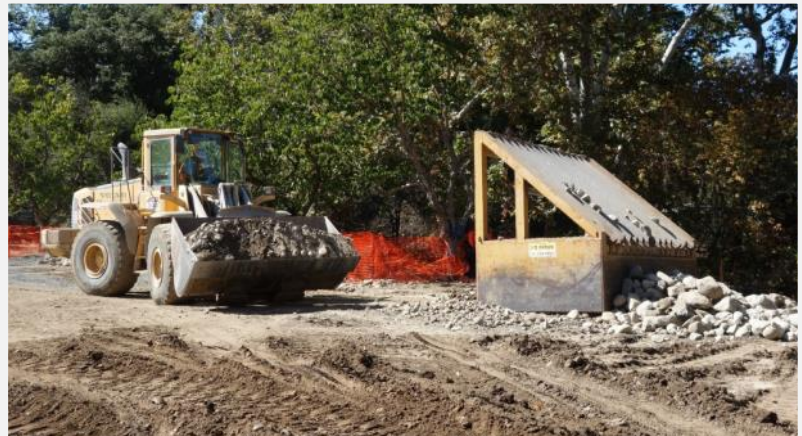
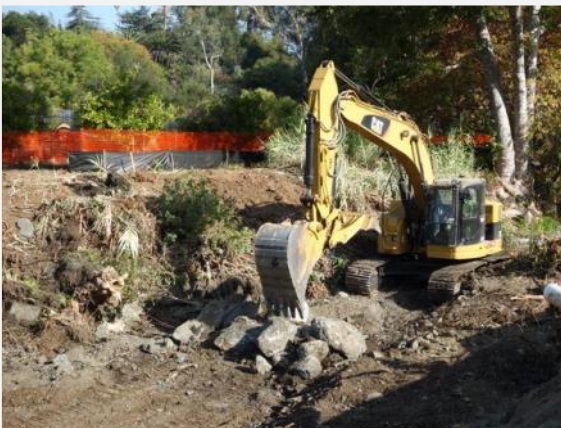
*C*obble material was harvested from the creek channel. It was sorted and re-used to create the new channel bed in pool and riffle areas. The cobble also provides spawning habitat for steelhead.

*R*ip rap armor removed from the banks was stockpiled. It was re-used to stabilize the new channel as buried toe protection at the base of the new creek bank.

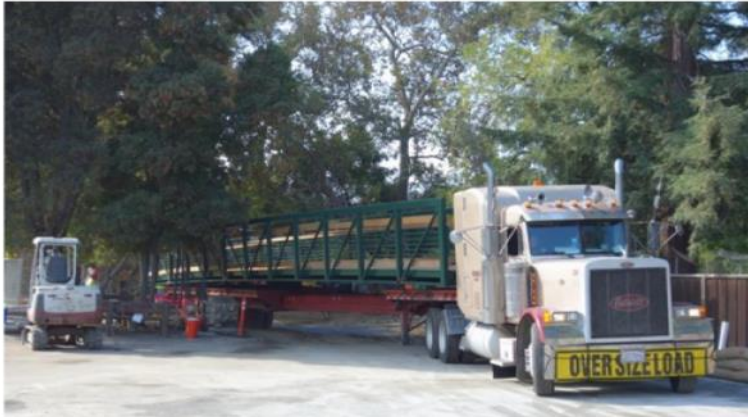
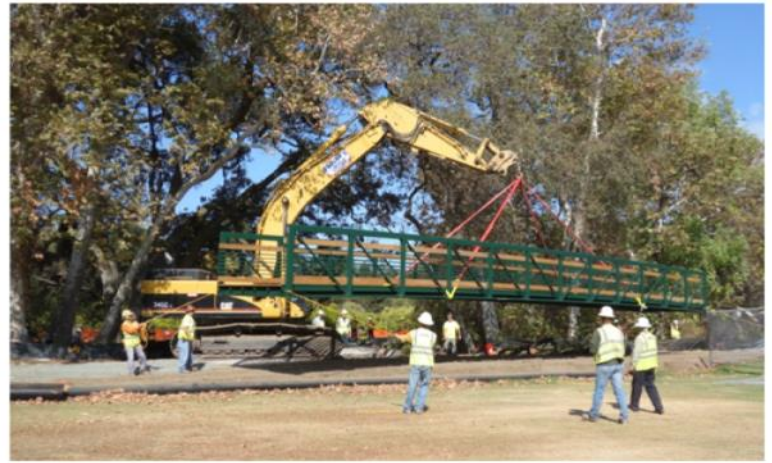
*A new footbridge was installed. The bridge is a clear span over the creek and is part of the trail alignment.*

*A site-specific strategy allowed for efficient placement of the span in under an hour and minimized impacts to the creek.*

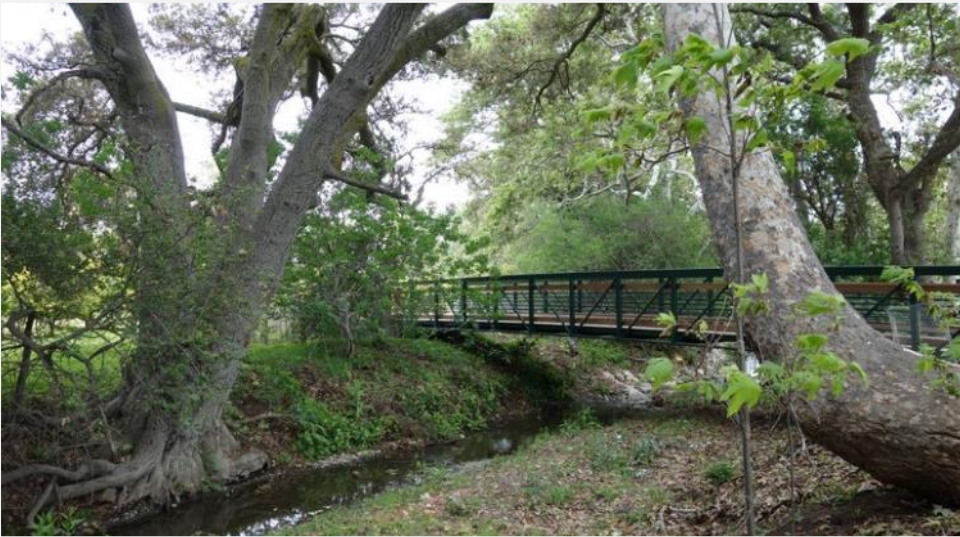
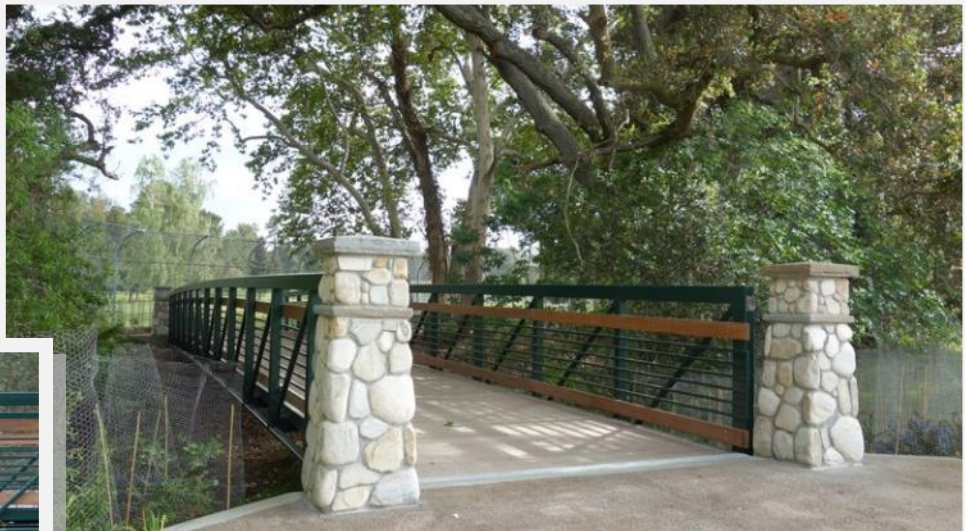
*The new bridge had to be carefully “shoehorned” between very large trees on all sides and their canopies.*

*The bridge span is set at an angle to the creek channel. This design provides gentler turns & is more inviting for cyclists. The angled layout also provides users more varied views of the creek. Excellent wildlife viewing exists here.*

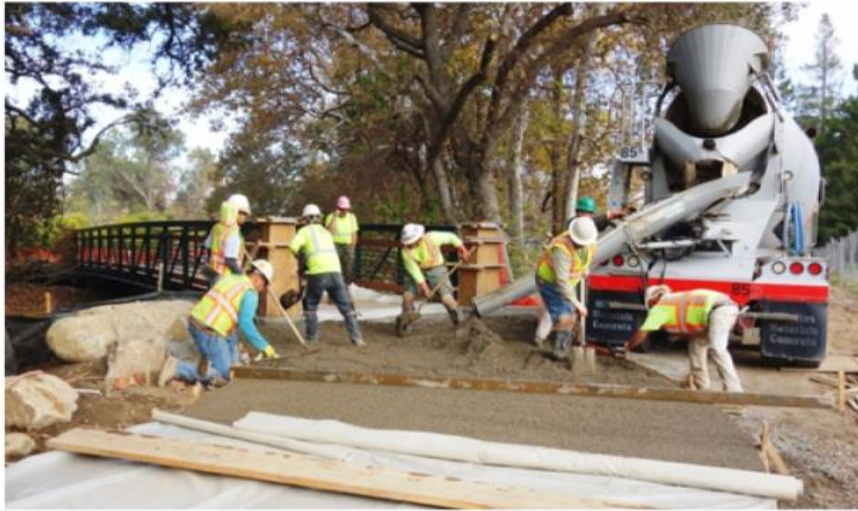
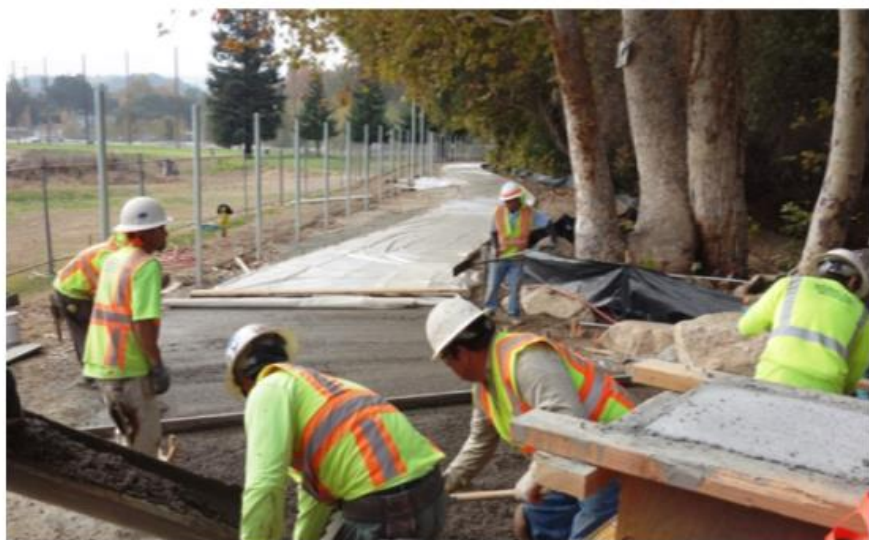
*T*rail paving was first installed on the east side of the creek.

*A* special paving and subgrade design was used where the trail had to be built in proximity to trees.

*This design better protects tree root systems.*

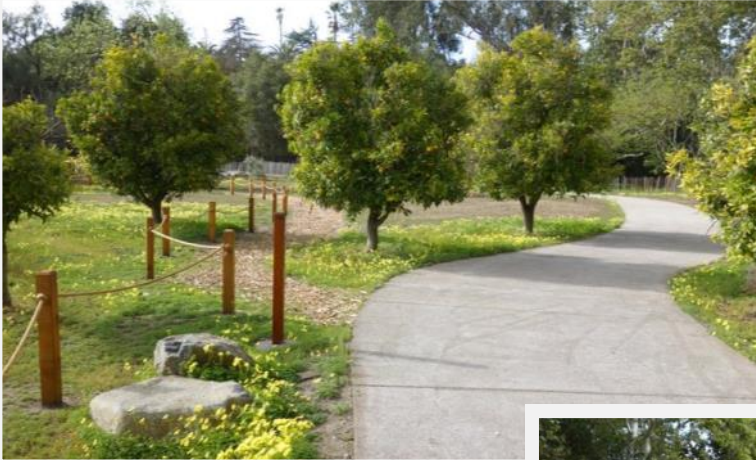
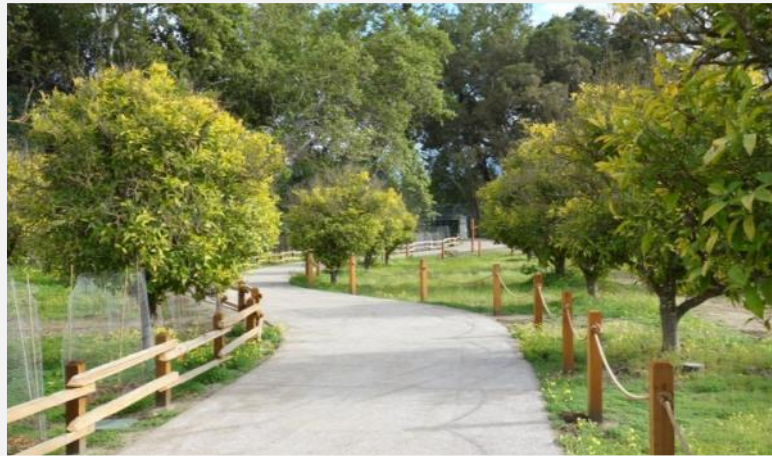
*An all-weather trail uses tan-colored pervious concrete paving.*

*The trail material is fully accessible, allows excellent infiltration, protects creek water quality, meets floodplain standards & is compatible with the creekside wildlife setting.*

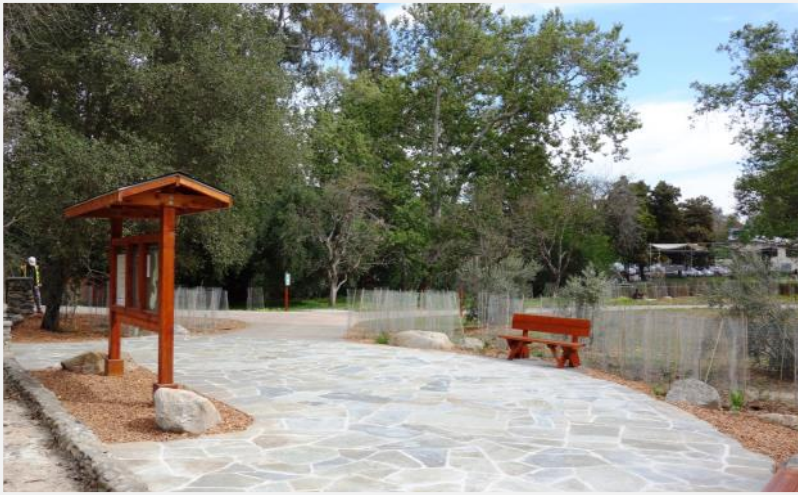
*The project site lies within a floodplain. The amenities are designed to tolerate occasional flooding without impacting aquatic wildlife or loss of public infrastructure.*

*A group gathering area, photo left, features flagstone, boulders, and naturally durable redwood for an information kiosk & benches.*

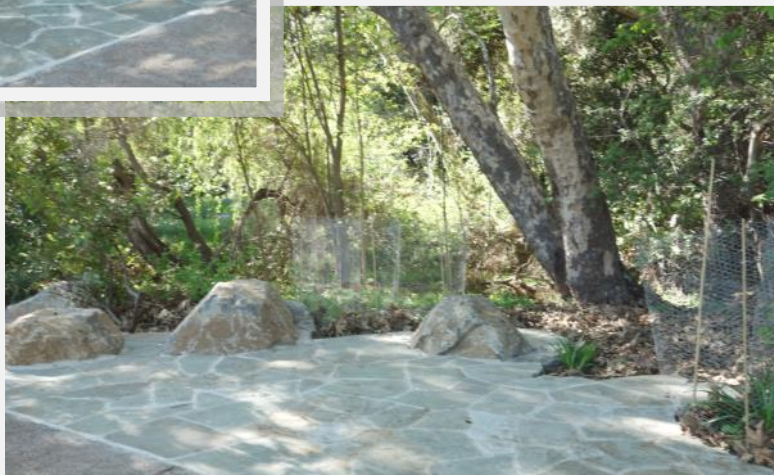
## Creekside Gathering Area

*A smaller creekside gathering area was created near the south trail entry. Its stone, boulders & plantings are "fish-friendly" materials that protect water quality, while allowing park visitors to enjoy the creek setting in a more intimate fashion & supporting local environmental education programs.*

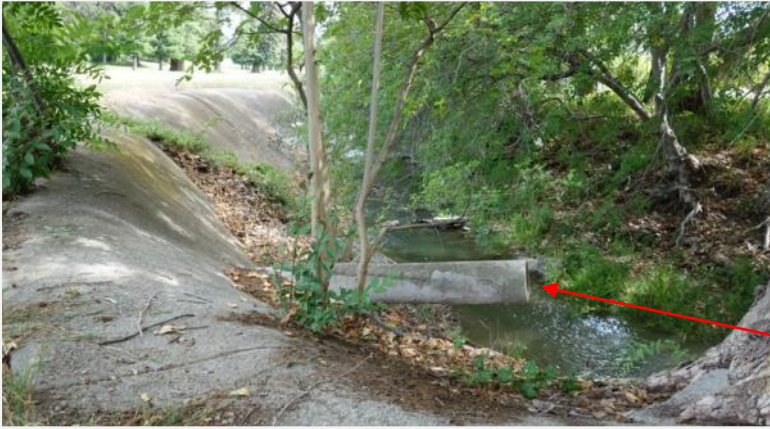
*P*rior to the project, runoff from the golf course and adjacent buildings & paving was piped directly into the creek channel.

Photo left, one of the several drainage pipes that projected into the channel, pre-project.

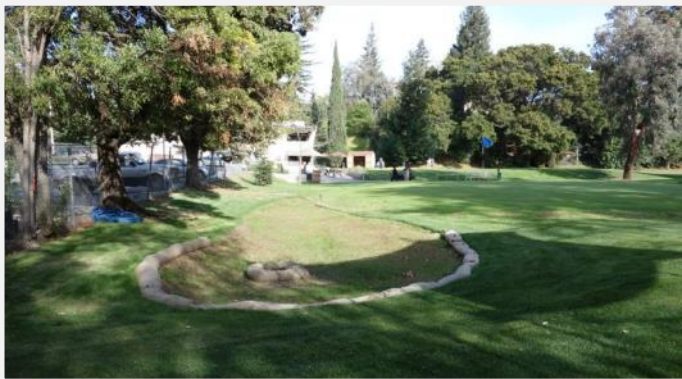
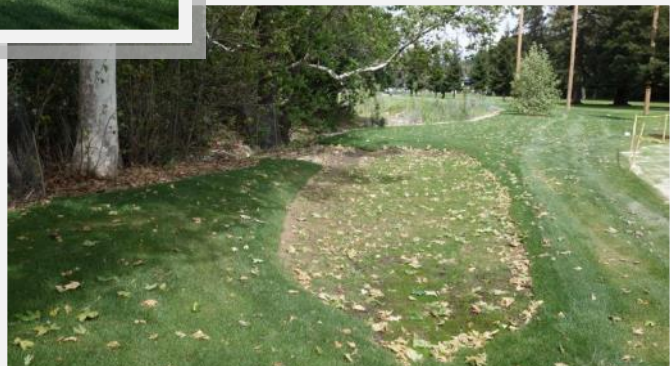
*T*wo of the new bioswales that now provide infiltration, photos above and right.

*N*ew bioswales along the east side of the creek / west side of the golf course provide infiltration areas for runoff from the golf course and paving. The bioswales capture and filter runoff that previously went directly into the creek, and will protect creek water quality. The swales also help provide natural watering for the "wet-feet" riparian plantings along the adjacent creek banks.

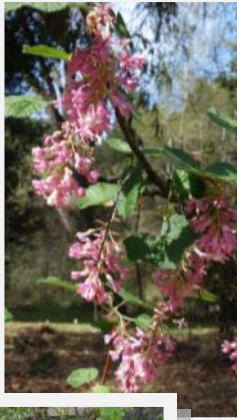
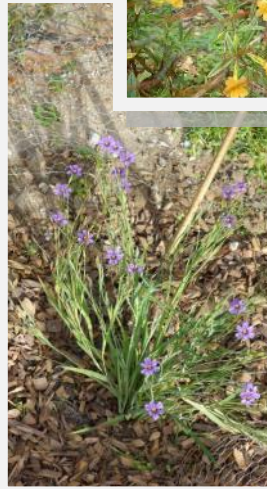
*Over 1-1/4 acres of new restoration plantings were installed, using over 2,000 native plants grown from locally-collected cuttings and seeds. Six dozen species were selected to restore the sycamore-cottonwood riparian forest and adjacent oak woodland.*

*Temporary cages protect young plants from wildlife browse during establishment.*

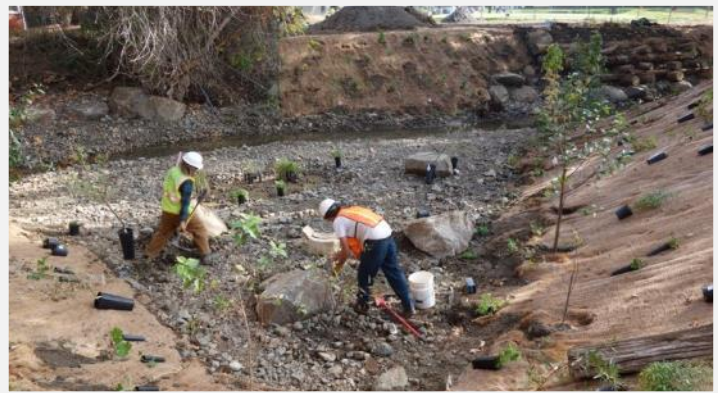
*Native trees were grown from cuttings collected from the creek. Advance planning allowed several years of growth prior to planting. The alder trees were set along creek edges where they will be naturally "watered."*

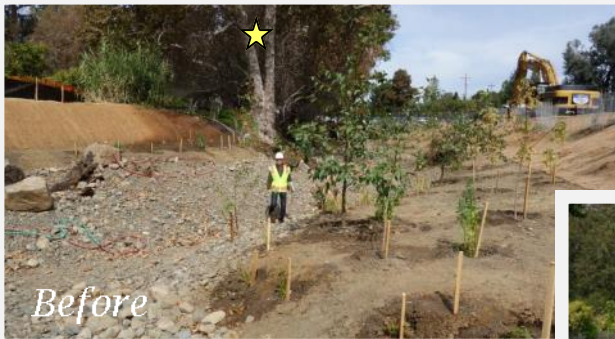
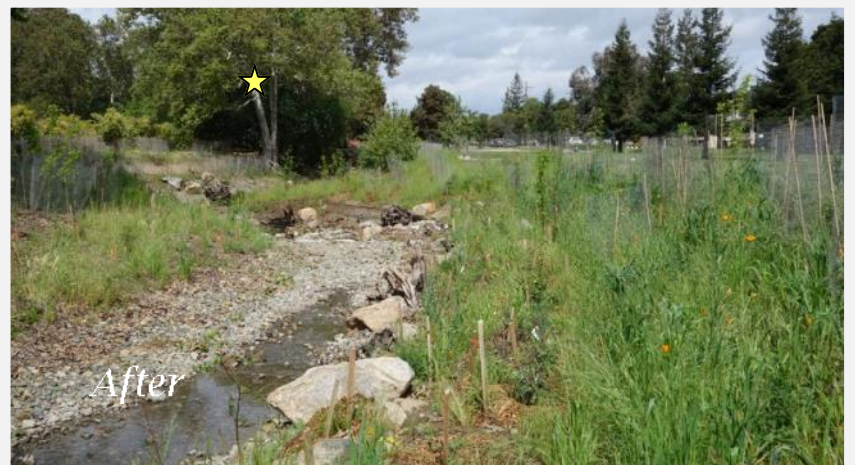
*New plantings are establishing well.*  
Photo left, Oct. 2013. Photo below, March 2014.

*A star marks the same tree in each photo.*

*Plants installed in areas outside the channel are watered by a temporary drip irrigation system & will soon need no water beyond natural rainfall. The riparian plantings were installed in the fall to maximize establishment success.*

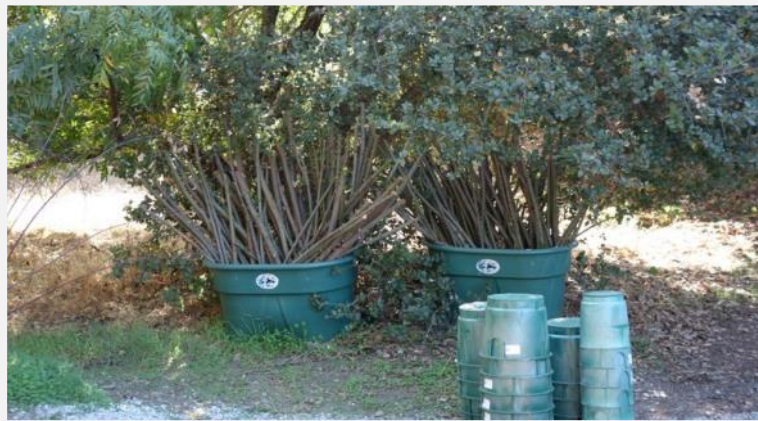
*Willow stakes were harvested from adjacent sites along the creek. After soaking in water and timely planting, the stakes grow quickly and help stabilize the new creek banks.*

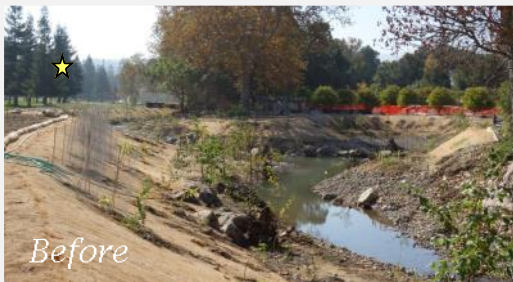
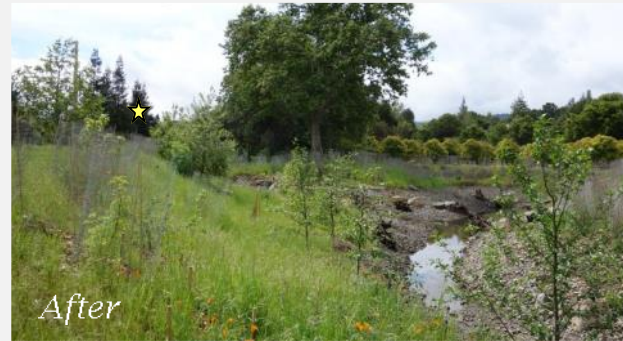
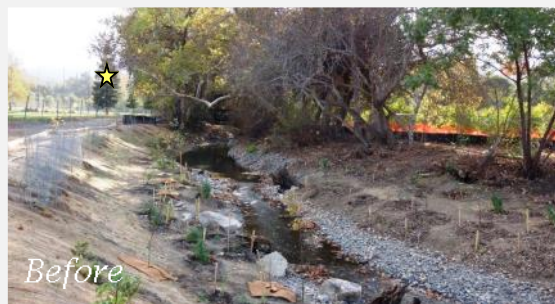
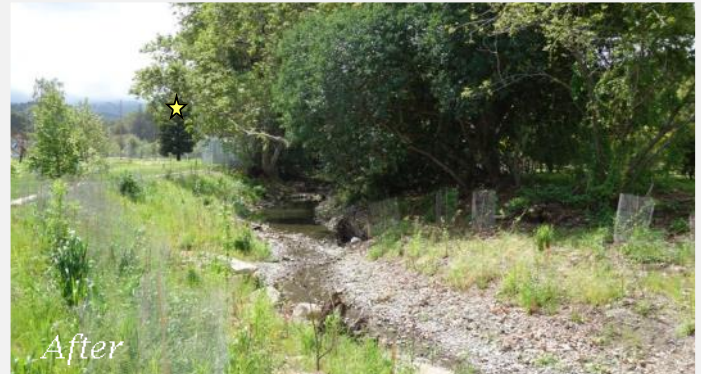
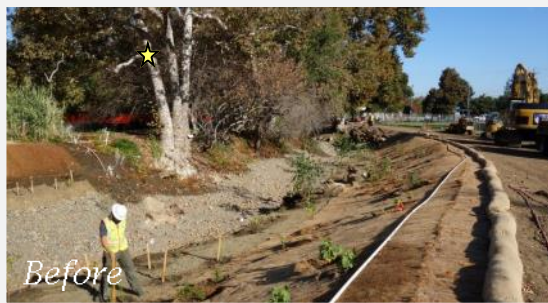
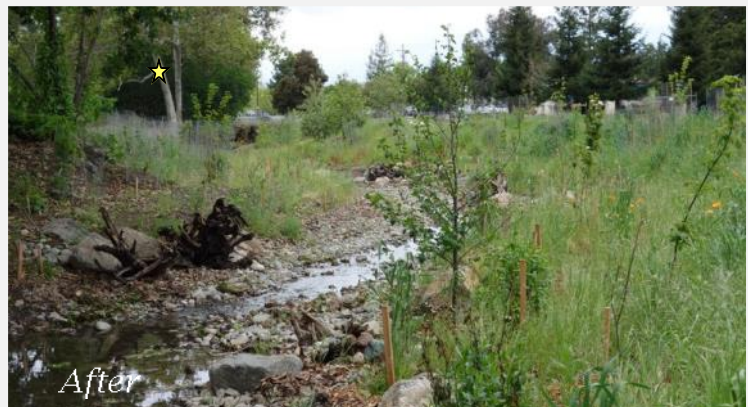
*A star marks the same tree in each pair of photos.*

*These paired photos show the progress of the native plantings installed on the new creek banks in fall 2013. Photos on left are Oct.-Nov. 2013. Photos on right are March 2014.*

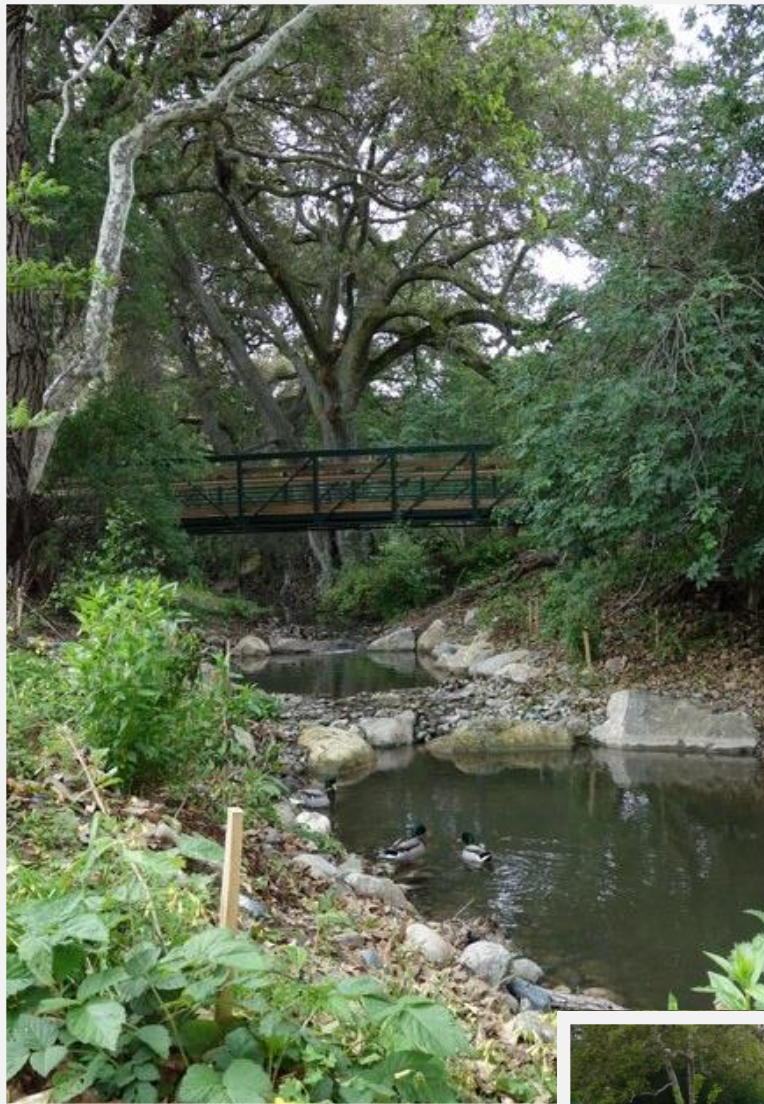
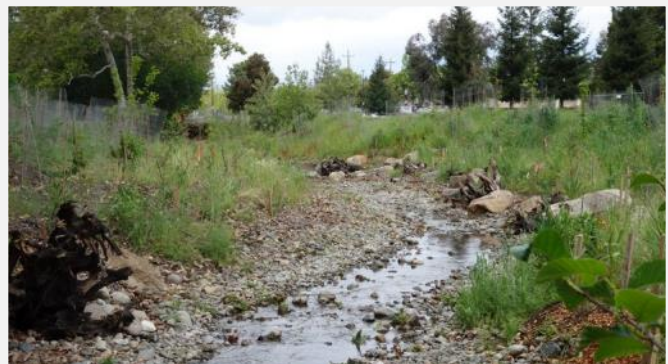
*The creek restoration design used natural creekbed forms found upstream of the project, & created a stable channel without use of concrete or man-made products.*

*The new channel was constructed entirely of natural materials, many harvested from the site: boulders, earth, tree trunks and rootballs, cobbles/gravels for the creek bed, and plantings.*

*These photos show newly-widened sections of the creek, 5 months after completion of the channel earthwork.*

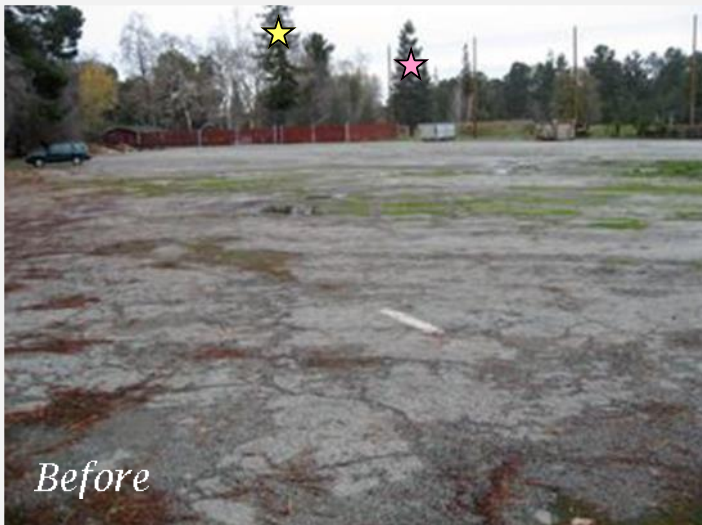
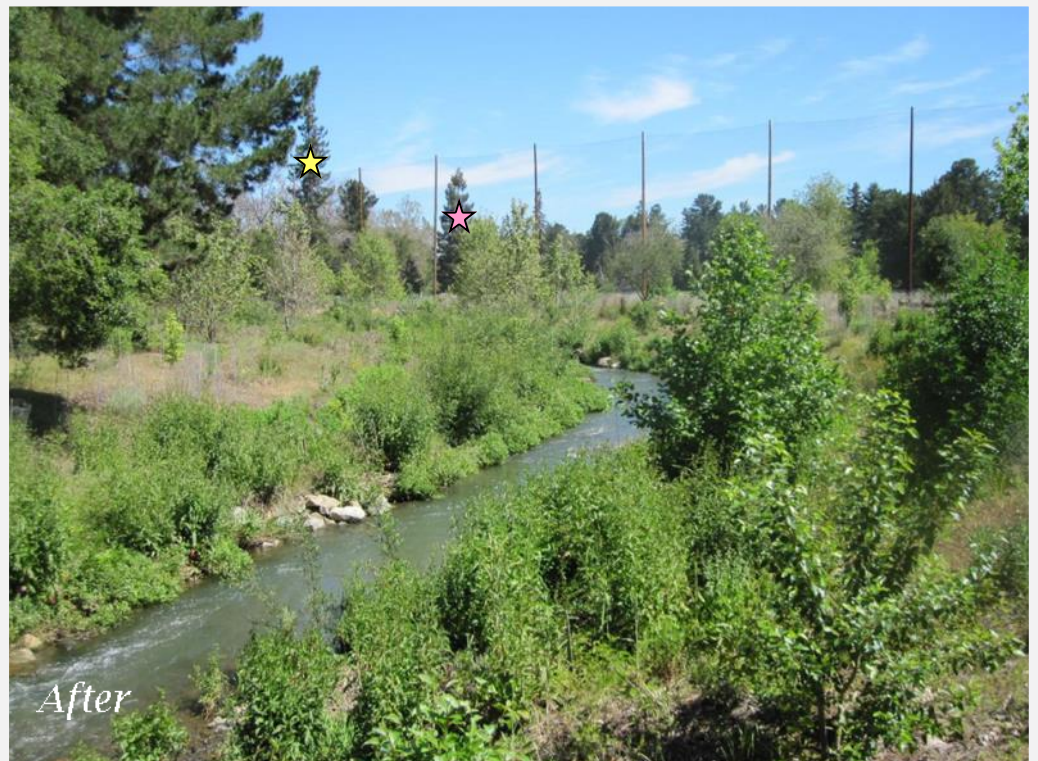
*L*ower parking lot, before. The creekside portion of the parking lot shown in photo left was removed, & became part of the new creek channel. This allowed creation of a wider, stable and healthy channel configuration.

*After: The new wider creek channel, created where parking had existed — Spring 2010, 1 year after project completion.*

*The new channel allows for desirable in-stream floodplain “benches” and supports greater habitat complexity. 3 drive-through crossings & a former dam were removed. The channel slope is gradual & there are no longer barriers to fish migration.*
