CASQA 2015  
Awards Program

Nomination for  
Outstanding  
Sustainable  
Stormwater Project  
June 5, 2015

## Stevens Creek Corridor Park & Restoration, Phase 2

# STEVENS CREEK CORRIDOR PHOTOS

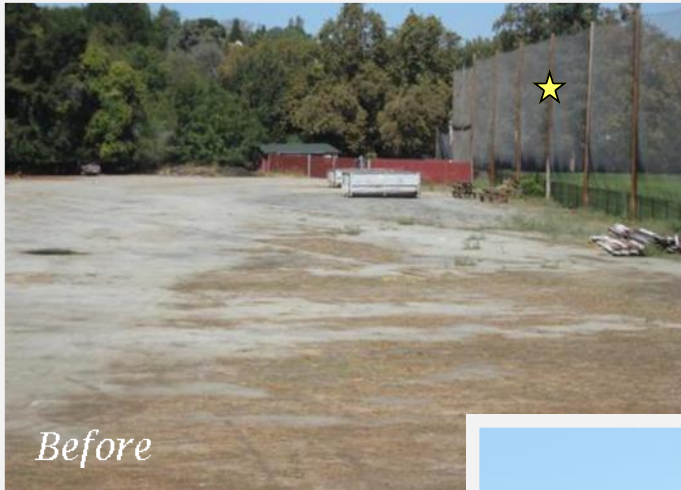
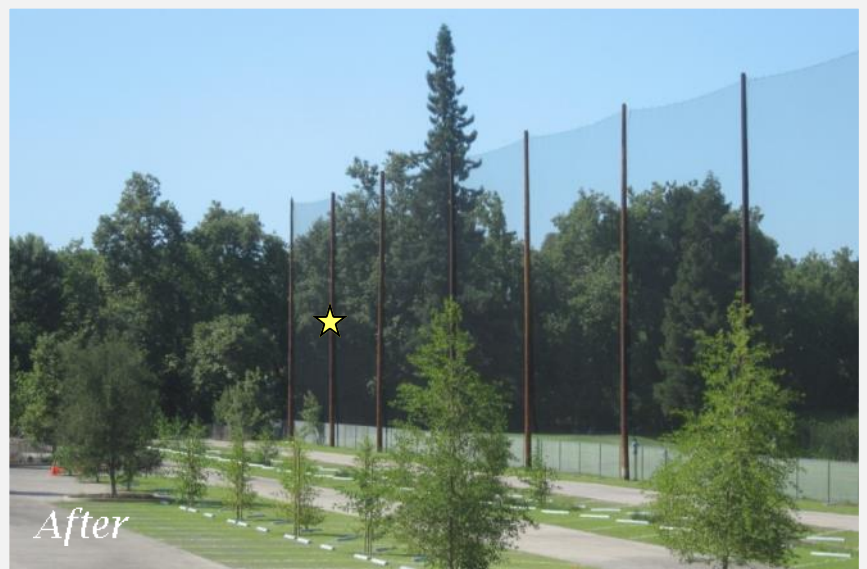
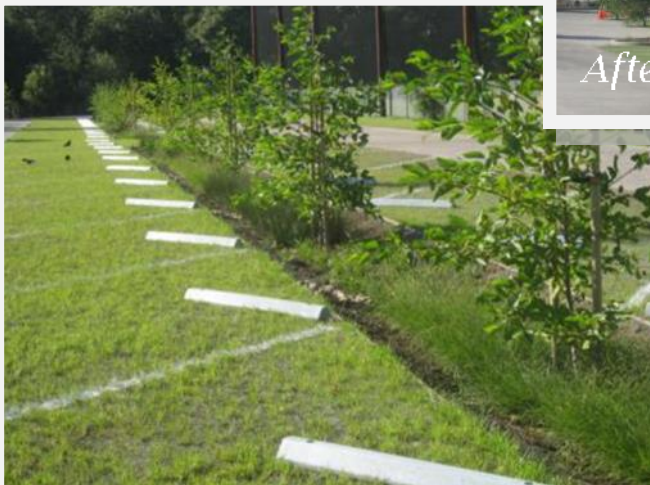
*The former parking lot, left, was made of impervious asphalt & extended to the edge of the creek channel. Its runoff drained right into the creek. It was removed & replaced by a smaller, “green”, completely pervious parking area.*

*The new parking area is set back from the creek & is entirely permeable. Drive aisles are porous concrete. Vegetated parking bays are seeded with native meadow plants, with turf rings to support vehicle weight. Dozens of native trees add shade.*

*After: Storm flows now infiltrate into grasses in “meadow” parking bays & permeable paving. During heavy rains, excess water flows to a bioswale & waters its ‘wet-feet’ plantings.*
