## Storm Damage Repair Project – Glenwood Drive

County of Santa Cruz

Civil and Structural Engineering

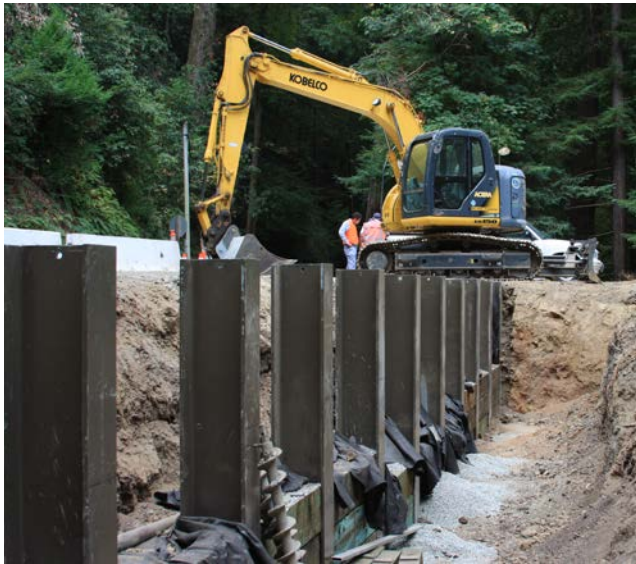
14 inches of rain fell in 14 days during a series of storms that hit the County in March 2011 resulting in damages to 35 County maintained roads including Glenwood Drive three miles north of Scotts Valley.

Our Geotechnical Engineer determined the failure at this site occurred in loose fill 14 to 16 feet below the surface and that the bedrock was located unusually deep at 25-35 feet below the road. 35-45 feet deep beams were designed to secure the new wall into the bedrock. To reduce the beam weight and strength needs we designed horizontal, drilled, tie-backs to anchor the top of the wall into bedrock on the uphill side of the road and this strategy reduced the construction cost and improved constructability.

Public Works retained MME to design a repair and we developed plans for an 84ft-long and 8ft-tall wall.
