## West Cliff Soil Nail Wall Sinkhole Emergency Repair

Santa Cruz, California

Civil & Structural Engineering

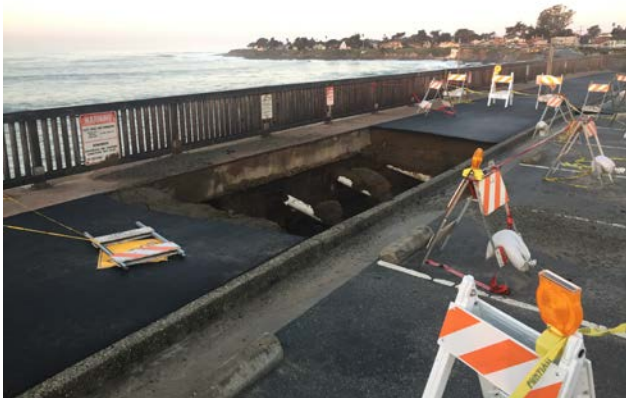
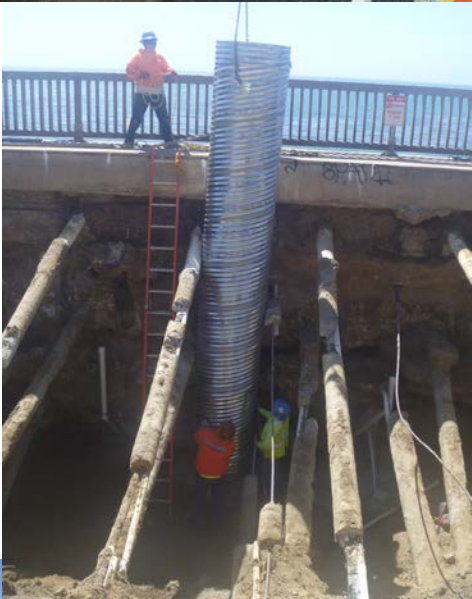
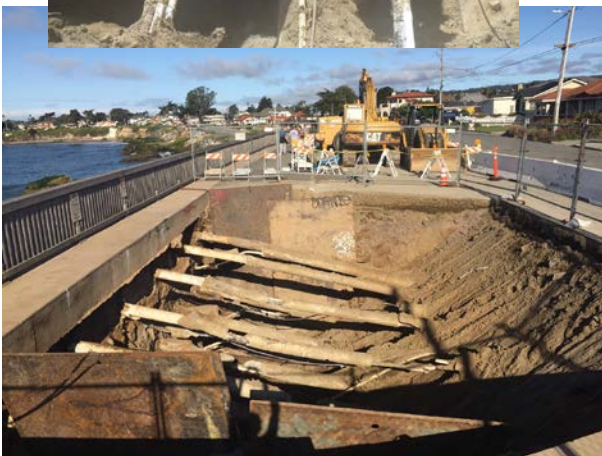
The 40 foot wide and 20 foot deep sinkhole opened up after a winter-long series of El Nino storms pushed heavy swells against the bluff, eroding the sandstone and protective boulders from below an existing retaining wall along West Cliff Drive.

To repair the latest sinkhole, MME quickly provided emergency design details for Salinas-based contractor Don Chapin Co. to shore up the existing retaining wall using 200 tons of 5 ton boulders and protect the area from further damage.

The second phase, concentrating on ensuring the long-term viability of the area, involved creating a drilled pier-supported retaining wall inside the existing soil-nail structure. MME worked closely with geotechnical and coastal engineers Haro Kasunich & Associates to develop the creative and cost-effective design. Our expertise enabled the City to rapidly restore this beloved coast road and walking path.
