Dee-Morin Slide Repair Los Gatos, California

Civil and Structural Engineering

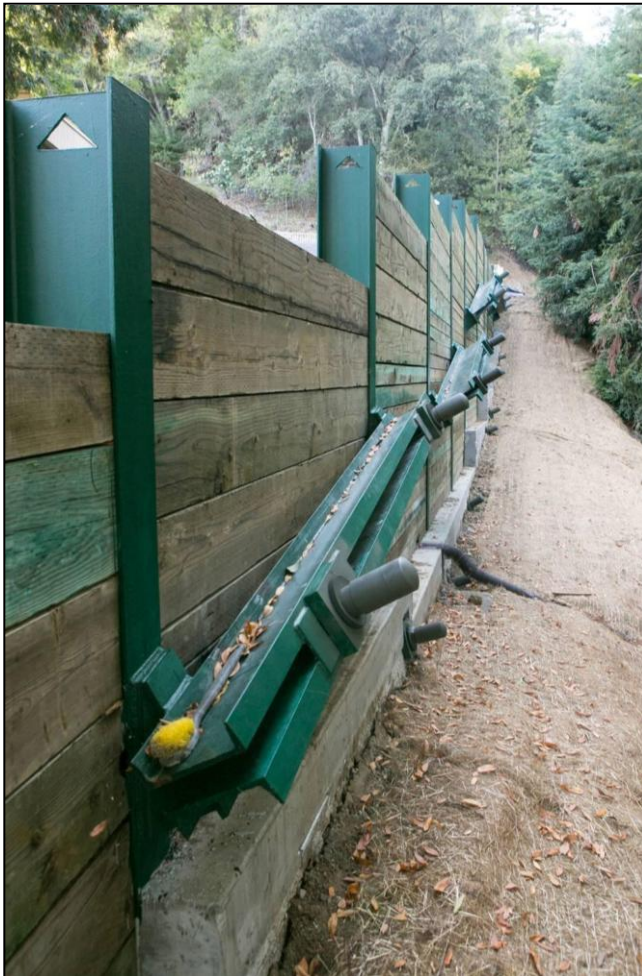
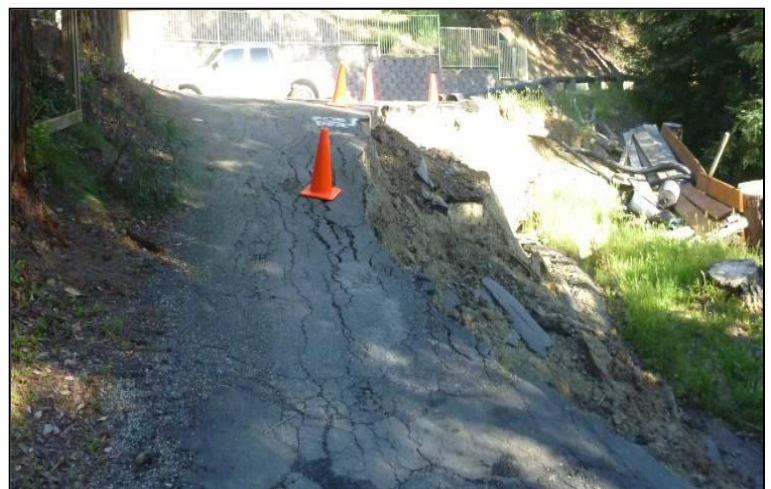
MME provided the civil and structural engineering expertise necessary to restore the Morin Access Road after a March 2011 landslide took out the road. We designed a 100-ft long, tied-back soldier beam retaining wall to support the rebuilt road and restore access to this mountain home.

To overcome the very poor soil conditions identified by Pacific Crest Geotechnical Engineers (up to 15-ft of loose fill over 10-ft of clay over mudstone bedrock) our design utilized CIDH concrete piers up to 40-ft deep, tied together with a concrete grade beam and laterally supported by 50-ft long grouted tie-back anchors.
