Graham Hill Road Water Treatment Plant/Slide Repair Santa Cruz, California

Civil and Structural Engineering

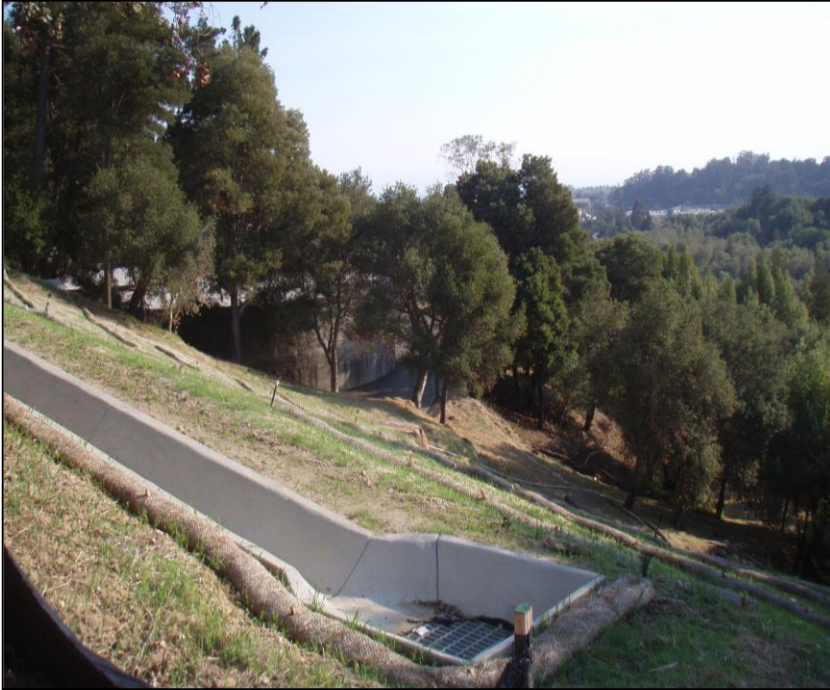
A major slope failure occurred northwest of the City of Santa Cruz Water Treatment Plant in April of 2006 due to saturated soil conditions, additional rainfall, and unstable fill material. The slide was located down gradient of a level bench, from which unconsolidated fill had been placed over the years, leading to a steep soil profile and unstable soil conditions. The mud and debris from this slide washed down slope and partially onto a neighboring property threatening the treatment plant.

Due to historical drainage patterns, there was a second, older slide immediately adjacent to the western property line which was identified as requiring stabilization and repair. Due to its proximity to the property line, a steel soldier pier and lagging wall 12 feet high was used to stabilize the toe of the slide.

Mesity-Miller Engineering served as the prime professional for the design team on this slide repair project and was responsible for coordinating the efforts of the multidisciplinary team. The repair design work included a base keyway, grading, and a top to bottom storm drain system.

MME used alternative analysis software for the slope stabilization to arrive at the most cost effective repair solution. Our design's finishing touches included grading, drainage, and pavement improvements to the storage tank area.
