## Redwood Drive Slide Repair County of Santa Cruz, California

### Civil and Structural Engineering

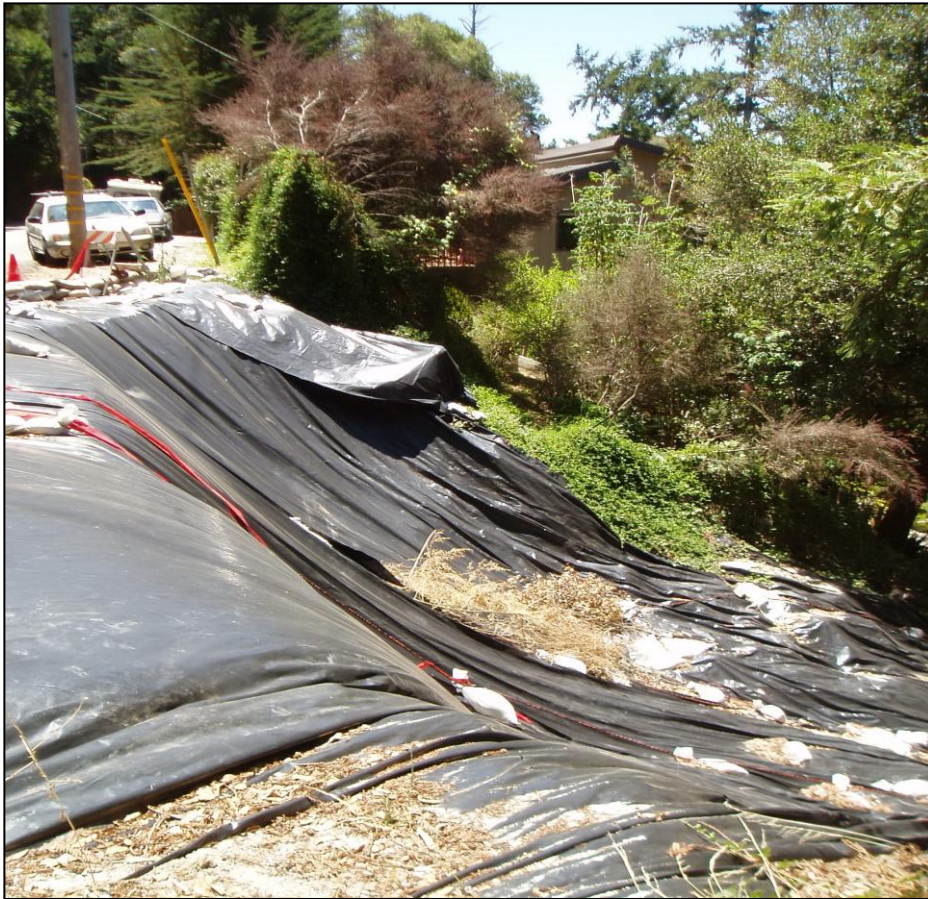
A large rain event in the winter of 2005 caused a slide adjacent to 1959 Redwood Drive in County Service Area (CSA) #33, located in the hills above Aptos in Santa Cruz County. The slide undermined approximately 40ft of road shoulder and left an 8-ft high near-vertical scarp adjacent to the roadway.

Mesiti-Miller Engineering was chosen by the County of Santa Cruz to design repairs for the damaged roadway and stabilize the adjacent slope. By constructing a soldier pier tied-back retaining wall below the roadway along the length of the damaged area, our design was able to repair the road shoulder at minimum cost. Soldier piers were steel beams encased in concrete piers with wood lagging spanning between the piers.

The adjacent slide area below the wall was graded with a maximum slope of 2:1 and a new storm drain including a wall back drain system was installed. Our design sought to minimize the environmental impact of the repair on the natural surroundings by employing a detailed erosion control plan, preserving existing trees and using an appropriately placed energy dissipater at the storm drain outfall.

Our design included a new traffic guardrail, wider shoulder, and improved roadside drainage as well.
